Constructing “Gloved” Wings for Aerodynamic Studies

Marta R. Bohn-Meyer
Ames Research Center, Dryden Flight Research Facility, Edwards, California

National Aeronautics and
Space Administration

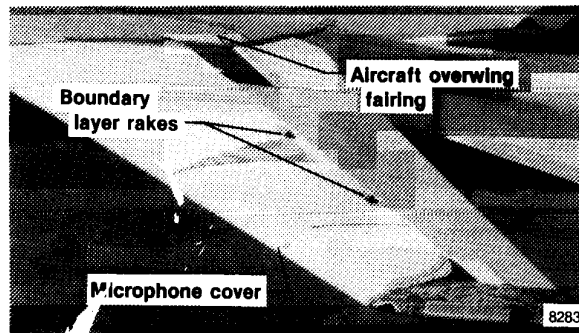
Fig. 7 *Left wing cleanup glove.*

To determine the baseline airfoil characteristics of the F-14A wing, a full-span cleanup glove (Fig. 7), with a surface finish conducive to natural laminar flow, was installed on the aircraft left wing. Thirty-five flights were conducted throughout a Mach number range ≤ 0.9 and at an altitude $\leq 45,000$ ft, providing the data base for developing the right wing glove contour and construction methods.

The thickness of the cleanup glove was a constant 5/8 in. and enveloped the wing from butt line 130 to 355 and from 15 percent chord (lower surface) to 60 percent chord (upper surface). The thickness was based on the preconstruction tests which determined the effect that the wing-to-slat joint movement had on the surface waviness and on an opinion that a thinner glove would not permit incorporation of the required instrumentation. The glove incorporated three rows of surface static orifices, two boundary layer rakes, three microphones, and provided for 40 surface pitot measurements. All instrumentation-plumbing and mounts were built in during glove construction, resulting in a continuous laminar flow airfoil throughout the glove span.

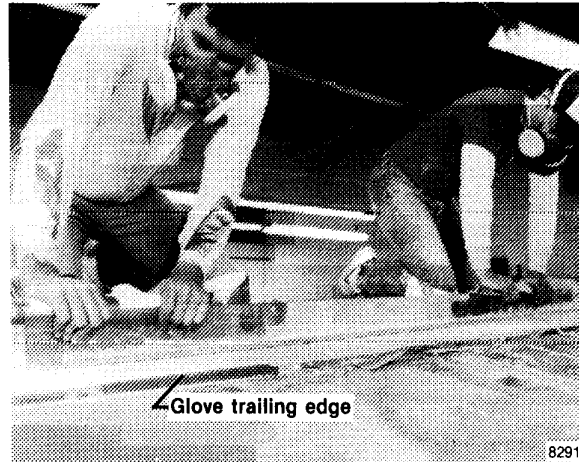
Fig. 14 Use of a spline board to contour the glove.

Step Six: Contouring the Glove. Shaping the glove to final contour was the most tedious and time-consuming effort throughout the entire glove construction process. This effort was consistent with Bohn-Meyer and Jiran² with minor modifications to accommodate differences in construction techniques.
